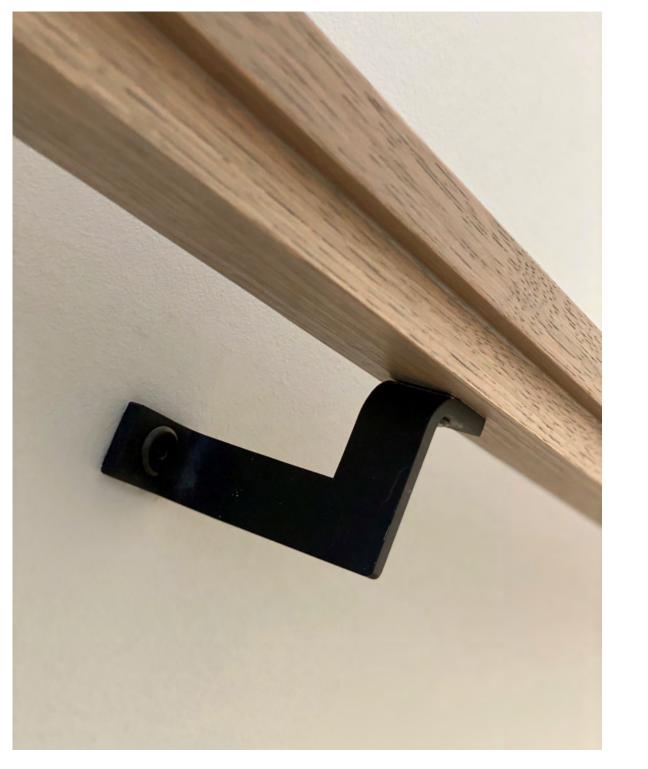
Best Stair Part

Aesthetic Value: Clean Modern Design without a Newel Post

Stair Safety: NO

Quality of Workmanship: Durable, Excellent Quality, Strong, Made in USA, Solid Steel. Furniture Grade, Quality Hardware

Technical Challenge: Fully Fabricated Curved Steel Stair System without Newel Posts

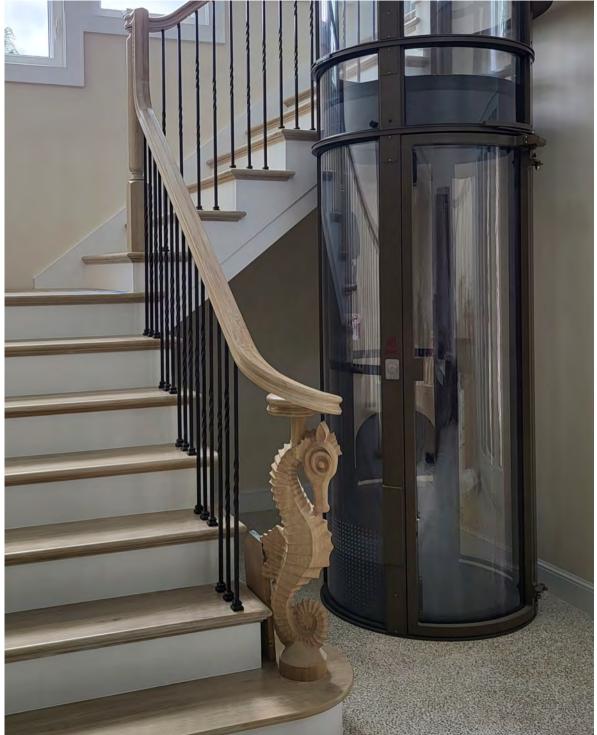
The sea horse newel and sea shell volute entering the stairs of this beach house set the atmosphere of fun for the entire house.

The large base of this newel gave the whole balustrade a great solid feel.

8/4 White oak glue up was selected for color and grain and lots of time was spent to get a good looking representation of the seahorse with careful attention to finish sanding.

Drawing this in 3D as well as programing the toolpaths.

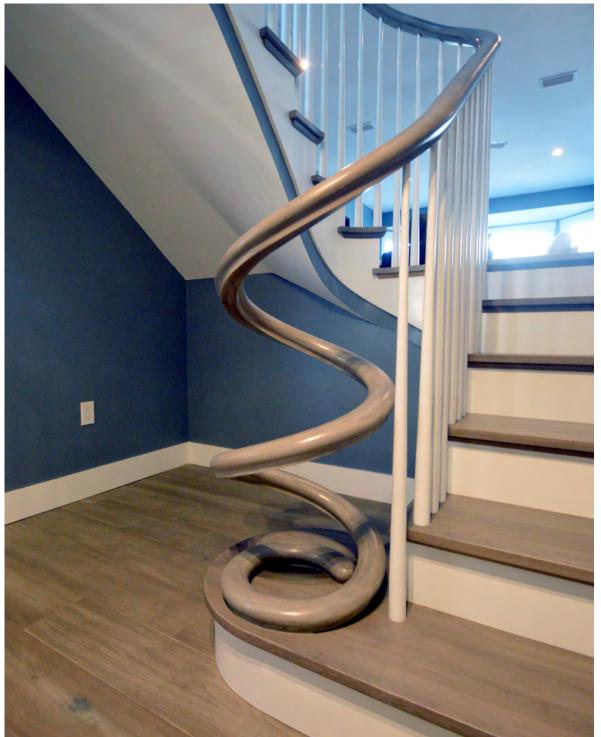
A spiral newel created out of the railing profile adds a unique element to this staircase. The rail flows all the way down to the starter step.

The newel is created in a manner that makes it look like it is floating in space yet it is still ridged and secure.

Color matched white oak was used for the blocks for a seamless look through the lightcolored stain with magnetic hidden fasteners used at joints for no visible plugs or fasteners.

It was a technical challenge to create the rail segments on our 5axis equipment and join them together to create an end product that appears seamless and in one piece.

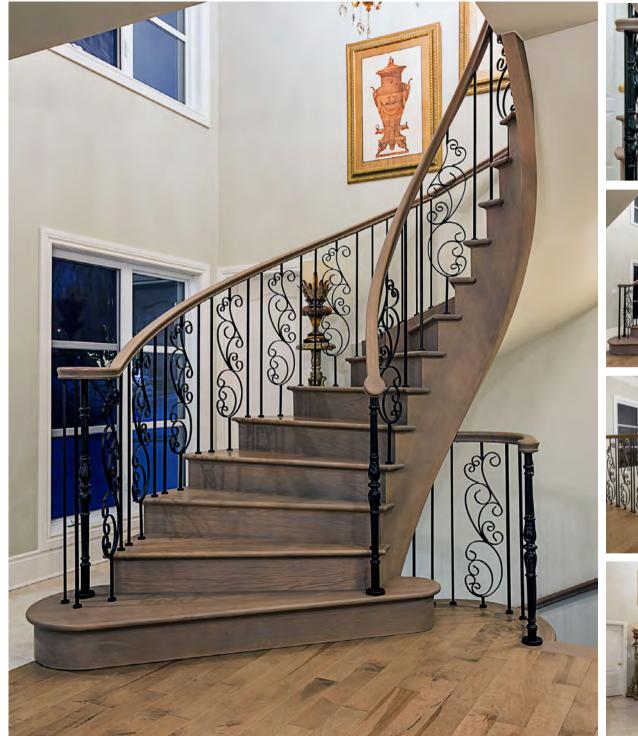
Each baluster gives added value and character to each staircase. Steel balusters in urban black from Prestige Metal.

According to the Code, this railings take the form of a banister with vertical balusters B012 and T010 from Prestige Metal.

All our balusters are painted in our factory. Dry powder paint is heat cured to high intensity. It covers uniformly and hides traces of welding and sanding. Durable, scratch-resistant finish.

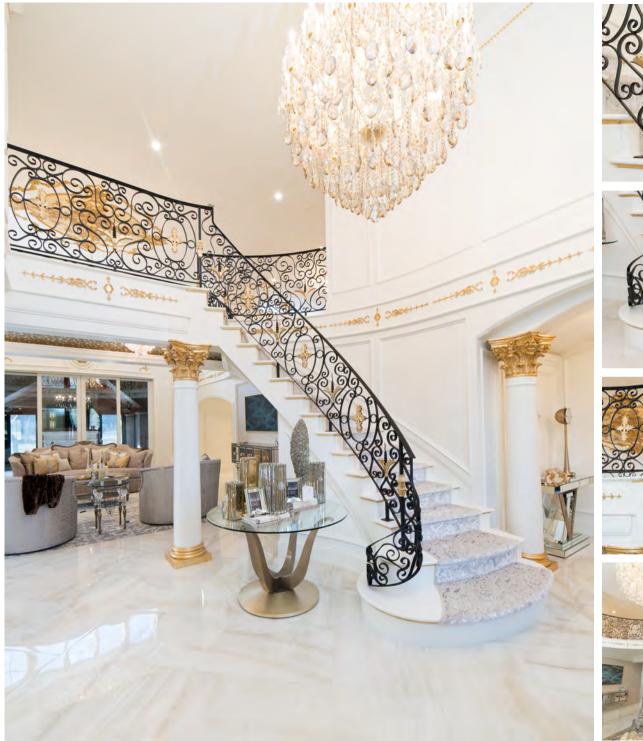
Custom iron balustrades as the focus of the entry and great room. The gold leaf accents compliment the many other gold features throughout the residence.

Guard height was raised slightly from the original to bring the handrail height to current codes.

The custom iron balustrade provides a sturdy guard and dramatic aesthetics to this previously plain foyer.

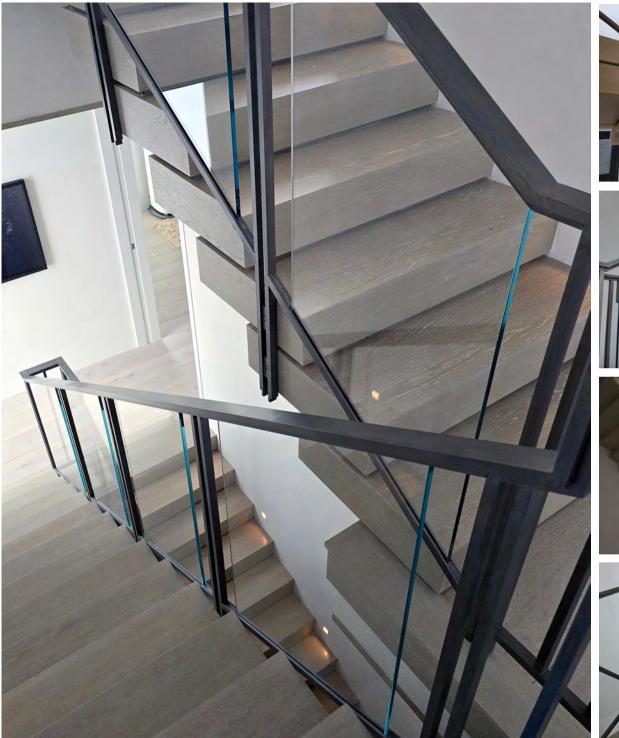
Modern straight balustrade with industrial vibes. The inclusion of glass panels with straight steel supports creates a look both monumental and open.

Complies with all codes and far exceeds all code required loads.

Natural steel finish, all welds are ground absolutely smooth and flush with all finishes blended. Each post has a machined step on the bottom tip and glass grooves were machined into the steel.

Designing a rail system that could be built of site with a detachable rail for access to install the glass was a challenge. The pieces had to be manageable to lift to install the glass.

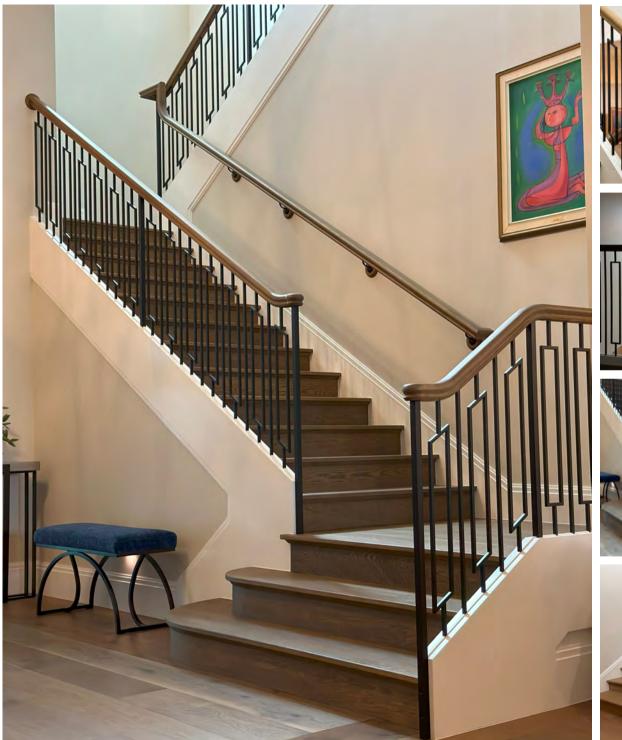
The stained would compliments the painted skirt boards and metal baluster system. The stair works with and enhances the design elements of the home.

The heavy steel post and solid half inch balusters provide for a very stiff and stable rail system.

The metal balustrade is carefully filleted in the rail and curbs to both create a finished look and to even further strengthen the railing.

The balusters were all made out of solid bar and welded to precise angles. The finish product was then powder coated.

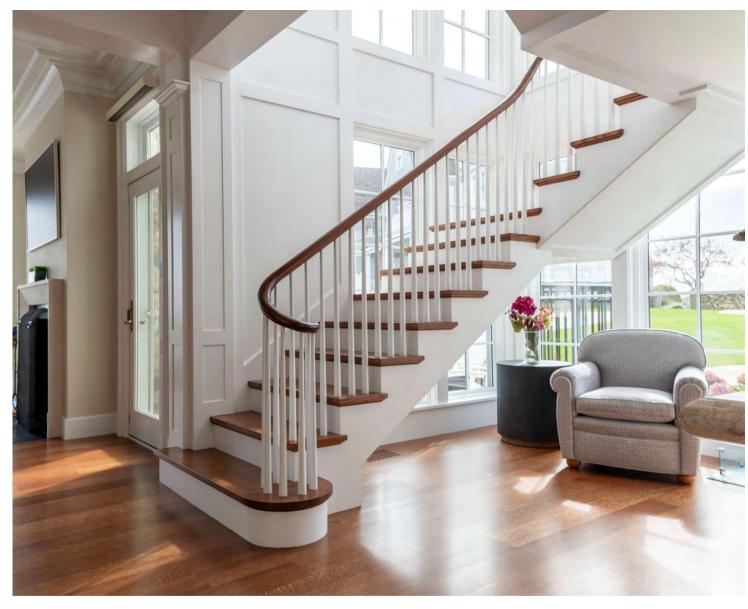
Stairs are totally unsupported with direct views to outside.

Rake rail height set to 34", Level rail height set to 36"

Poplar Primed stringers & risers w/Rift + Quarter sawn white oak treads, plank nosing, white oak cove scotia. Rail - sapele w/custom hand carved wreaths at transition points. Custom turned balusters.

We had to make some changes to the run to maintain the rake rail height on all those custom transitions.

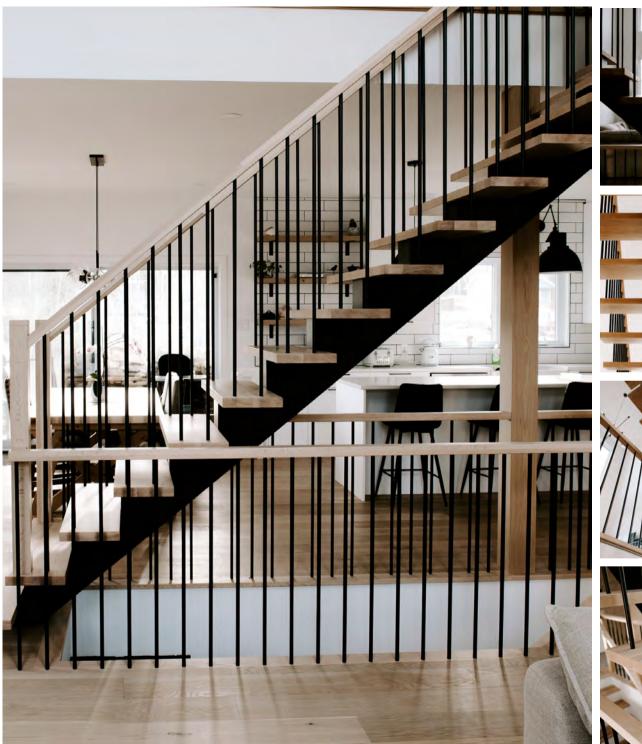
Mono central steel stringer to support its structure efficiently and uniformly. For a traditional and vintage look, we recommended steel stringer with balusters railings and wooden steps.

Stringers conform to the building code and have been approved by an engineer. It complies with the building regulations of the region where it's installed.

Each stringer is custom made thanks to a technical drawing. Steel stringer is painted (powder paint) in our factory. This one is in urban black.

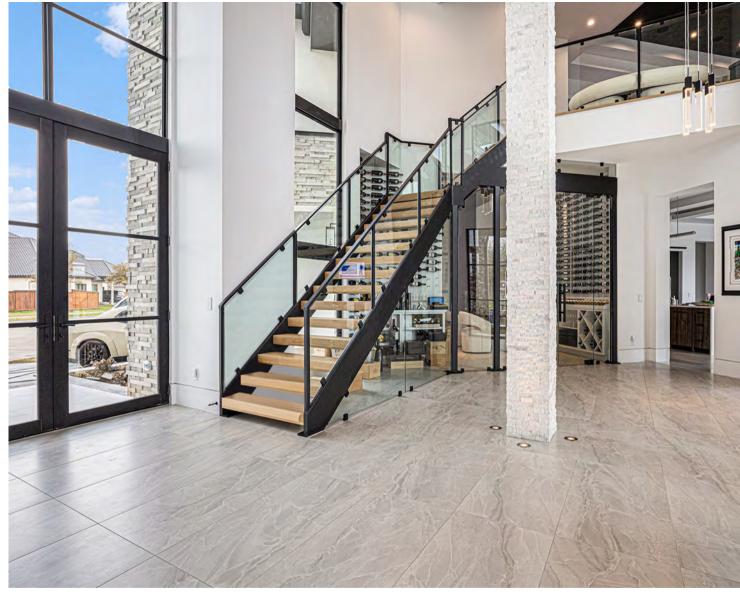
double steel stringer with block treads and glass panels

everything was installed at code with proper riser and rail heights.

We ended using all steel rectangular tube for the stringer with white oak butcher block treads and 1/2" tempered glass

this was not on the plan so we had to figure out what was the best possible way since this had a wine room underneath the staircase.

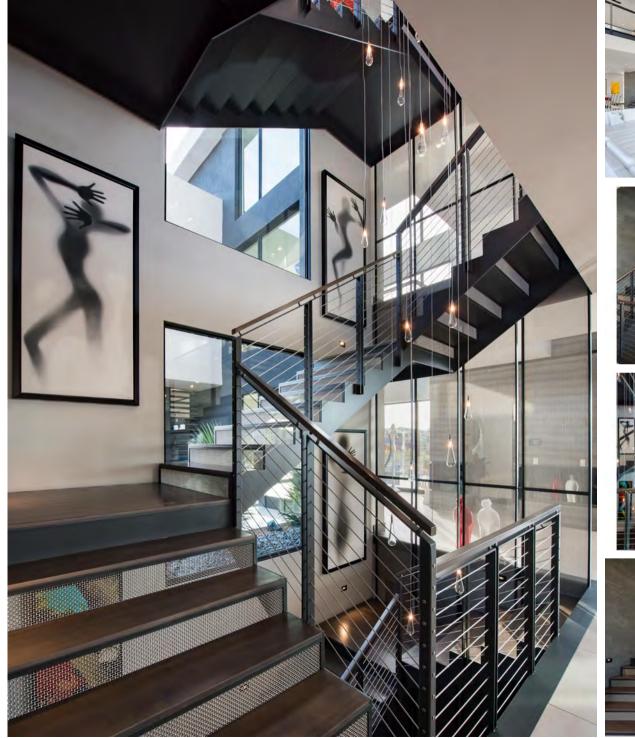
This unique stair has stainless steel mesh risers that we integrated into the plate steel stringers and maple wood treads

The code compliant handrail mounts on top of stainless-steel pegs. Each section of rail is modular and mounts on to the side of the plate steel stringer

This stair is 3 stories high. All 3 flights are suspended perfectly over top of one another.

If you look closely, one of the faces of the stair has a mesh screen that spans all 3 stories and integrates into the stair well. That was part of the stair install.

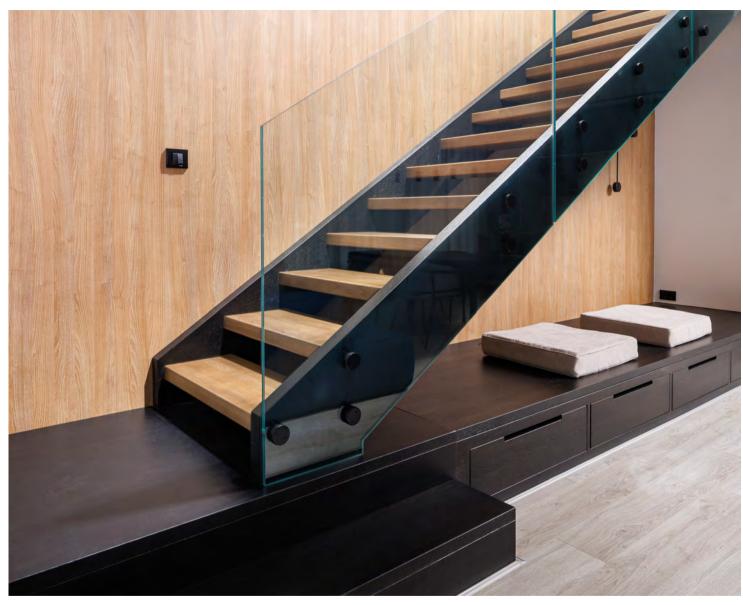
With a simple and elegant design, ingeniously integrating a drawer system for efficient storage and providing a practical and stylish seating space, the glass balustrade adds a contemporary touch

Premium 60mm oak, top finishing solutions, best glass quality.

Dimensions of the platform and fixturing system was the challenge for this project

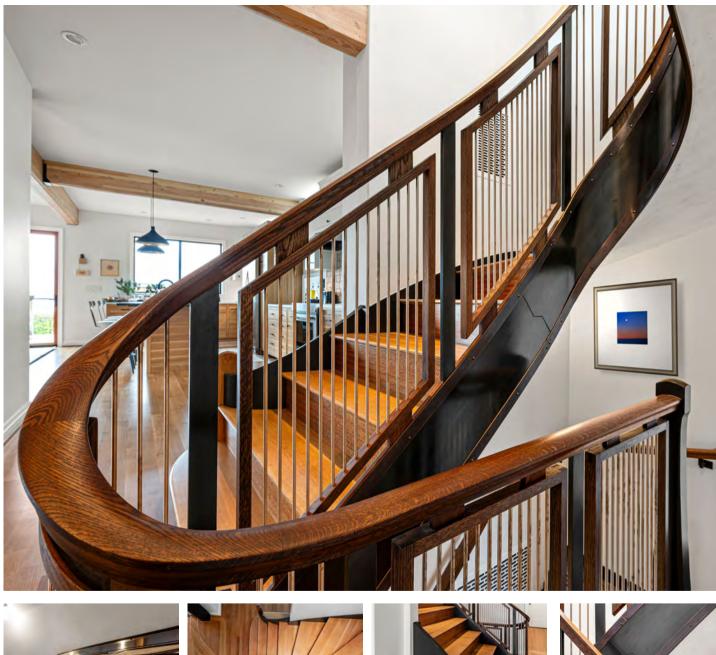
A sinuously compact, true jewel box of a staircase. Mid century styling blends silicon bronze, wood and gunmetal steel, featuring glamour plus practicality with a built-in bench and art drawer.

This stair would never have met code, so we required the architect to raise the kitchen and dining room a full 12" to ensure risers of 7 3/4" or less.

The stair combines the best of mid century materials and design, in a combining Q-sawn W. oak, ribbon cut mahogany, Plaster soffit

The impossible joint: Harry Potter style zigzag structural steel connections at the start and finish of the swirling 180° steel U-turn. Do you see the joints? Airtight tolerances.

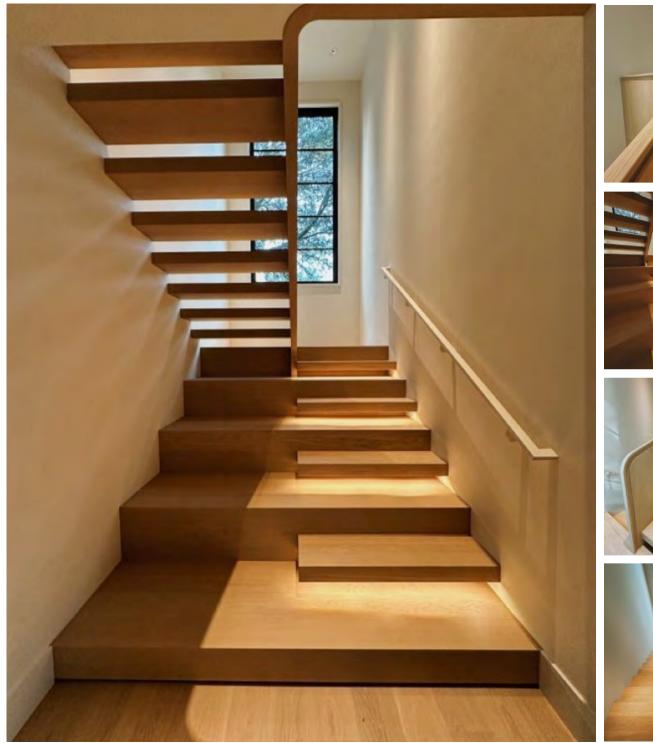
Maintaining the shadow line of the handrail consistently atop the rake wall to pony wall.

Floating treads supported by 5/8" large steel brackets.

Hand manufacturing the wreathed rake to level fitting

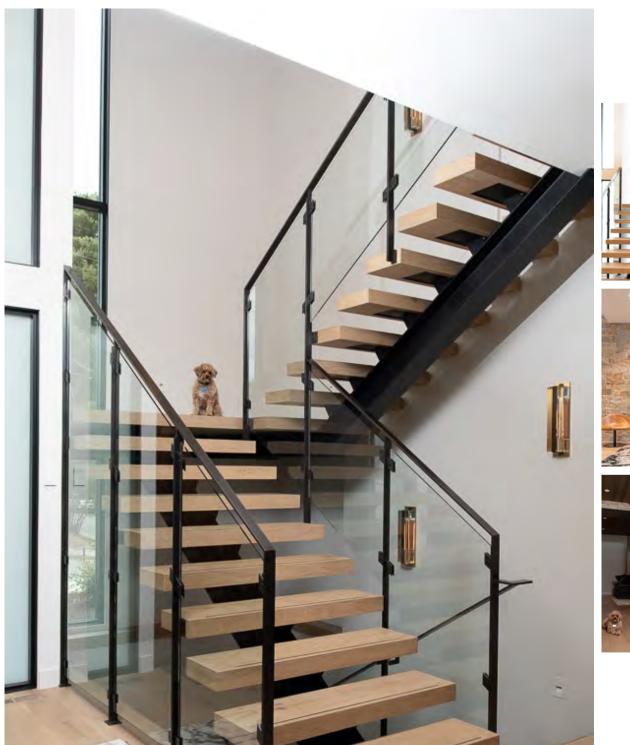
Custom Petina and Field Waxed Cold Drawn Steel Post and Rail. Premium, High End Fabricated Steel and Glass System with I-Beam Mono Stringer

Custom Glass Clamps. Multi-Level Glass and Posts

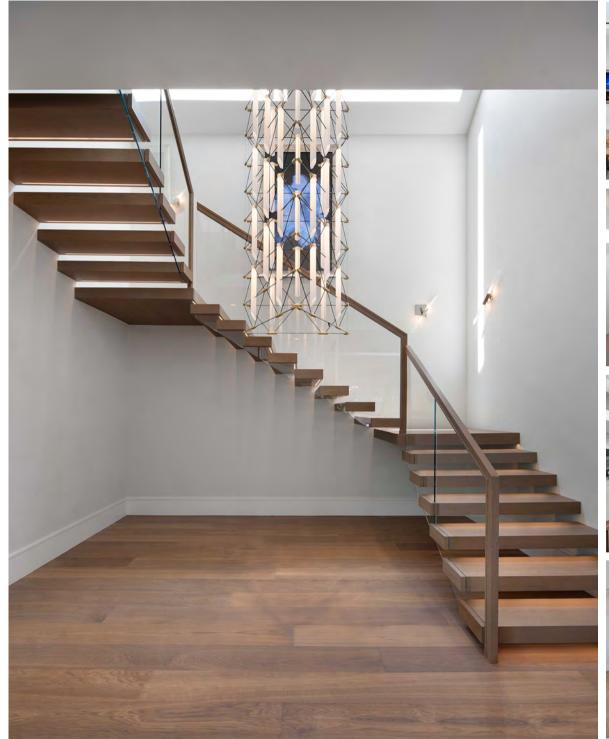
Simple modern flare with straight lines and floating cantilevered treads. Each tread is lit with a recessed LED light strip.

The project consisted of plain sawn European Oak and low iron glass. All glass mounting hardware being hidden by the wooden tread end caps.

Hidden steel supports and plates create a floating look. All supports and plates had to be installed and hidden within the wall cavity build out.

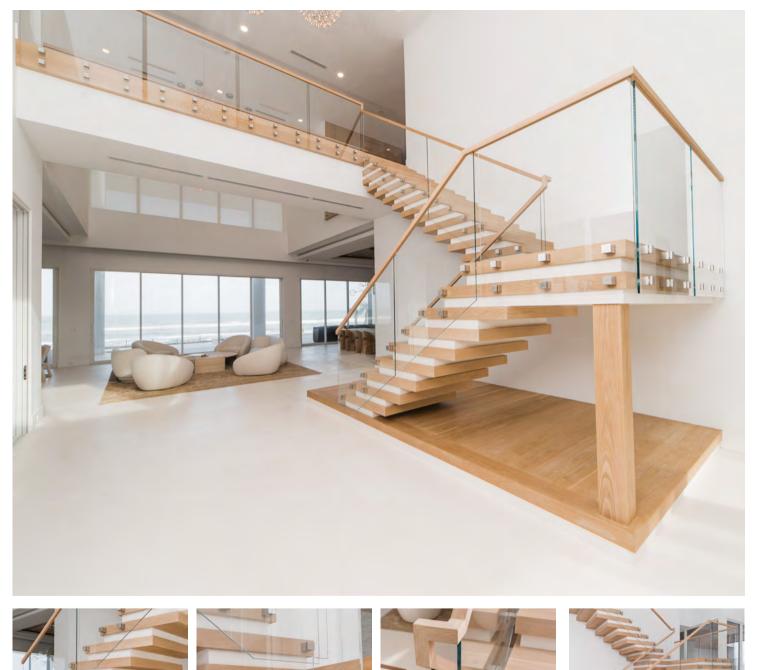
The stacked boxes configuration, glass, and sleek top rail contribute to provide crisp, clean lines of this stairway. The lines throughout the landing blend seamlessly with the rest of the stair.

Safety glass is used along with a plowed top rail to provide a secure guard.

The glass is low iron and the glass standoffs are solid 316 stainless steel.

The large stacked box configuration required extensive internal components to ensure a sound structure and allowed the boxes to be assembled on site. All exposed wood was lock mitered and face grain.

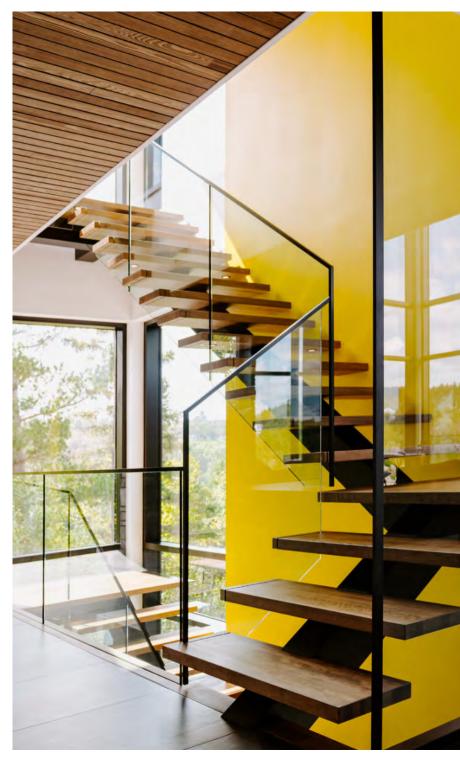
Mono central steel stringer to support its structure efficiently and uniformly. Subsequently, for a modern and minimalist look, we recommended glass railings and wooden steps.

Stringers conform to the building code and have been approved by an engineer. It complies with the building regulations of the region where it's installed.

Each stringer is custom made thanks to a technical drawing. Steel stringer is painted (powder paint) in our factory. This one is in urban black.

2 steel stringers First floor : Stringer with 3 winder steps and a 45° attachment. Second floor : Stringer in L-shaped with a 90° landing. Crossbeam at the top.

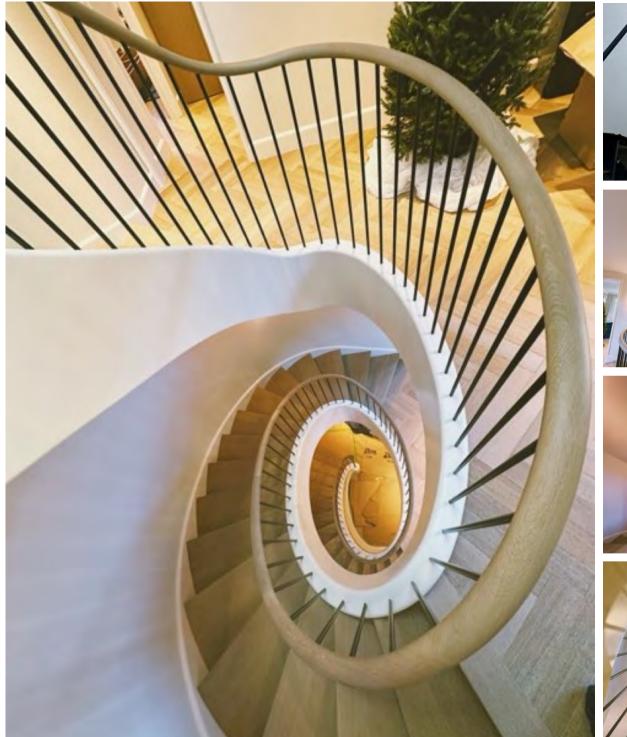
Staircase is main focal point of the home. Running from garage level to rooftop, 4 stories.

Being elliptical achieving a consistent 10" run at path of walk. Legal rail heights.

Collaboration with fellow SMA member, highest quality wreathed handrail parts. Pristine details for a multi-million dollar home in San Francisco's Pacific Heights neighborhood.

Laying out the steel beams to support landings during the rough framing of the house and craning in the stringers.

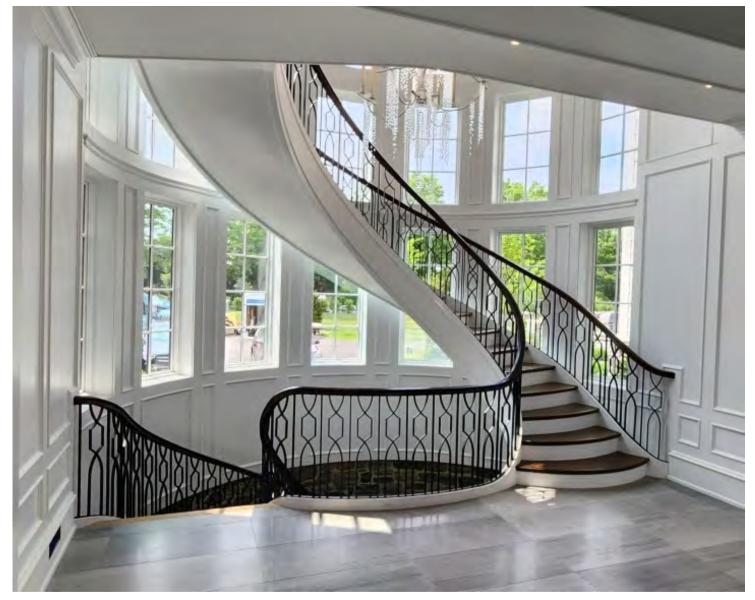
The freestanding stair provides elegant, sweeping curves as it passes in front of the windows of this curved stair tower. The handrail flows seamlessly throughout all floors.

The handrail provides uninterrupted graspability as you traverse the various flights. Walkline remains consistent throughout bowed winders.

The all wood carriage has embedded steel brackets to secure the stair to the structure a the top and base headers. Balusters were custom made our machine shop.

The balusters were machined with slots to slide two halves together without any welds for a very crisp look. The handrail was made with many custom wreathed fittings throughout various pitch changes.

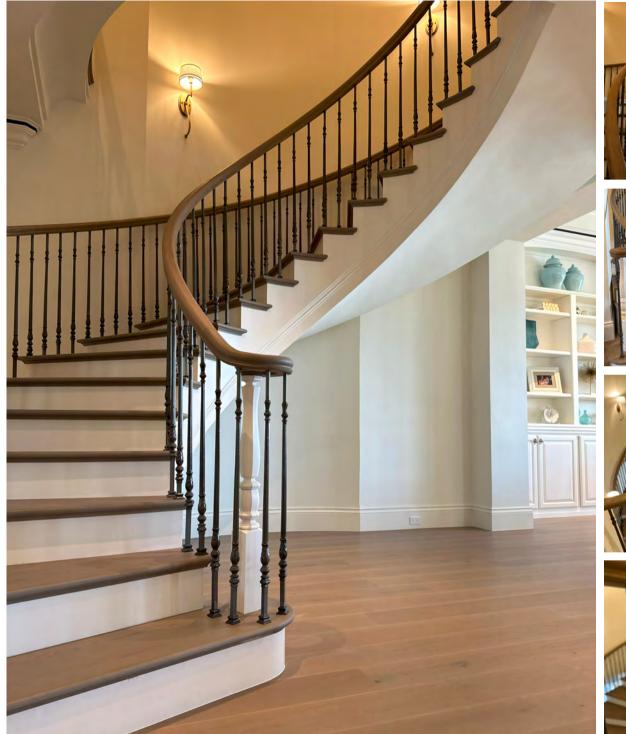
A flowing rail system with climbing volutes completes the package for this beautifully curved stairway. Solid hardwood rails and treads combined with metal balusters creates a picture of elegance.

The stringers, top, and lower mounting was designed to provide for a rigid structure with no bounce. Careful attention was paid to ensure all radiused parts followed the perfect path.

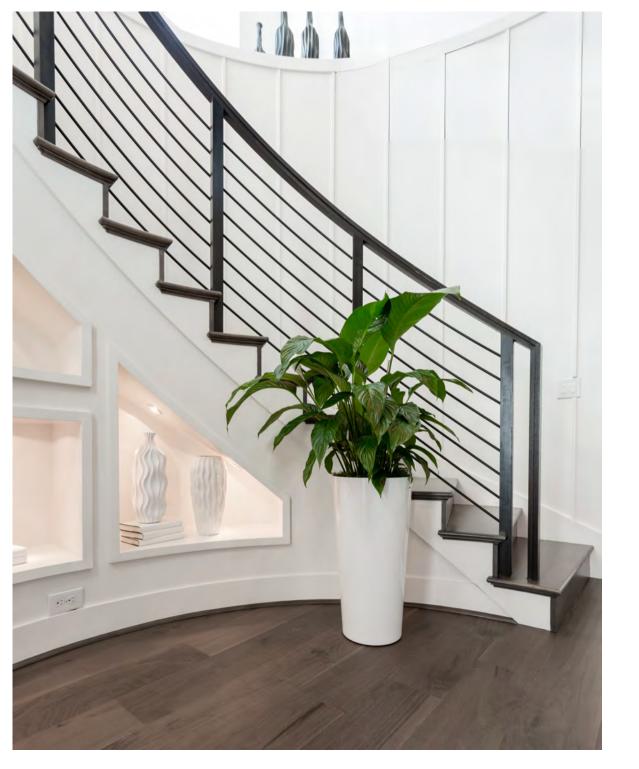
Best Curved Stairway - Modern

Quality of Workmanship: Black Stainless Steel Solid Rod with Stained Hardwoods

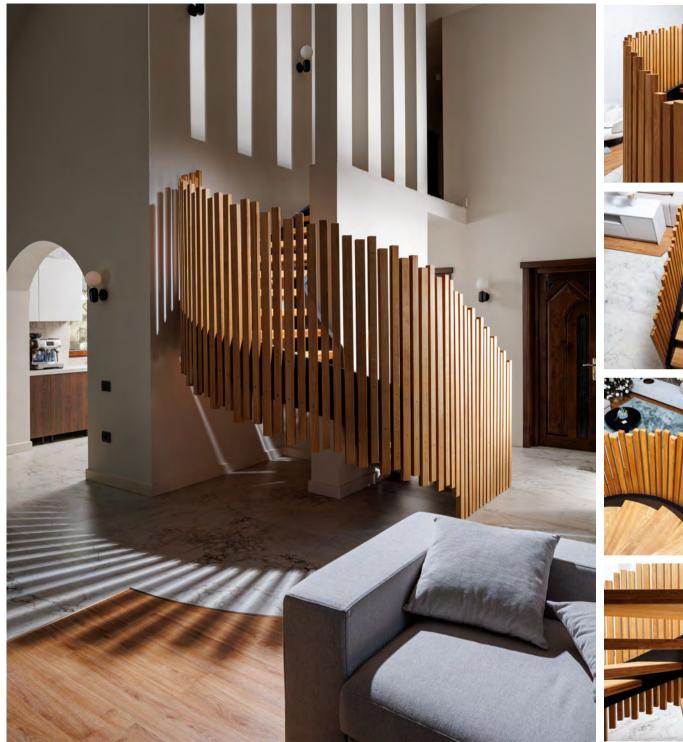
The curved strings made out premium oak, layered and machined in details, are the central point of this project, beside the asymmetrical balusters that give a unique signature.

Made out of premium oak, top finishing products from Bona and Rubio Monocoat, each detail controlled and refine form production to installation

This was the our first curve string with a radius bigger than 300mm

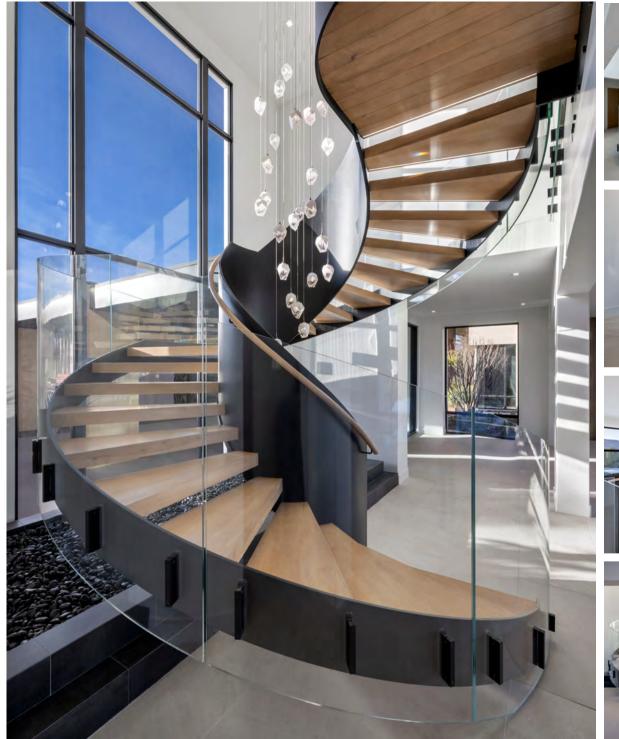
This Beautiful Stairway has a $\frac{1}{2}$ " plate steel inside stringer bent to a 27" radius. The outside stringer is 1"x12" steel. The Starphire glass is attached with standoffs custom made from 1" steel.

The Maple wood open riser treads are wrapped around a tube steel core with integrated LED lights. The handrail is also maple. 2" round profile

This stair had to be carted in the house in pieces to get it through the front door. There was a lot of site welding. The outside stringer wraps around to create a landing at the top of the stair.

Because of the custom standoffs, we could only use a 5/8" holes to attach the glass. That left us very little wiggle room to get the glass to line up. With no top rail the alignment had to be perfect

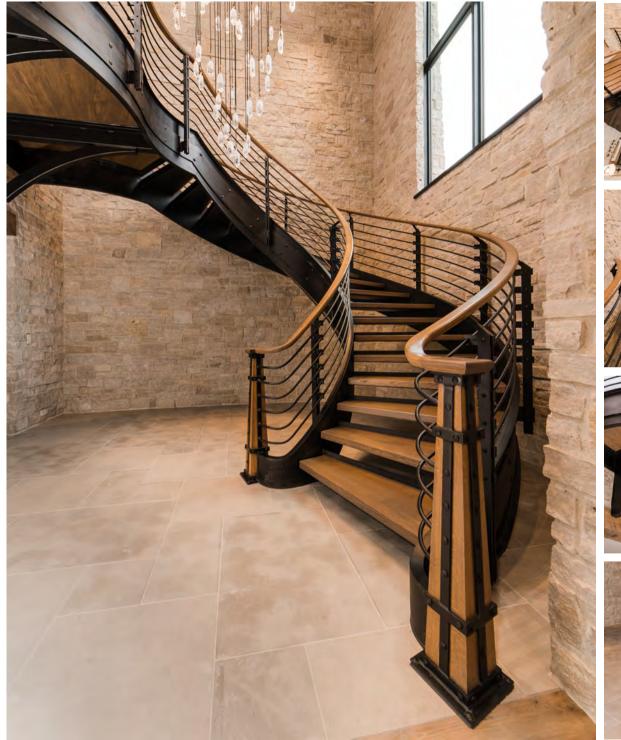
This design meshed an old world and a modern photo submitted by the architect. Large freestanding landing provides awe and small details like the hammered rivets provide a unique and pleasing look.

The space allowed for commercial rise and run in this private residence. The newel placement at the bottom provided additional handrail at the bottom of the stair.

The freestanding carriage and sizable landing are supported with curved C-channels fabricated in house. The grain direction on the large platform is arrayed to run parallel to the front and back edge.

Extensive rigging was required to erect the stair and landing because it was prebuilt in the shop and delivered in three pieces. Smart stain finish is applied to the metal.

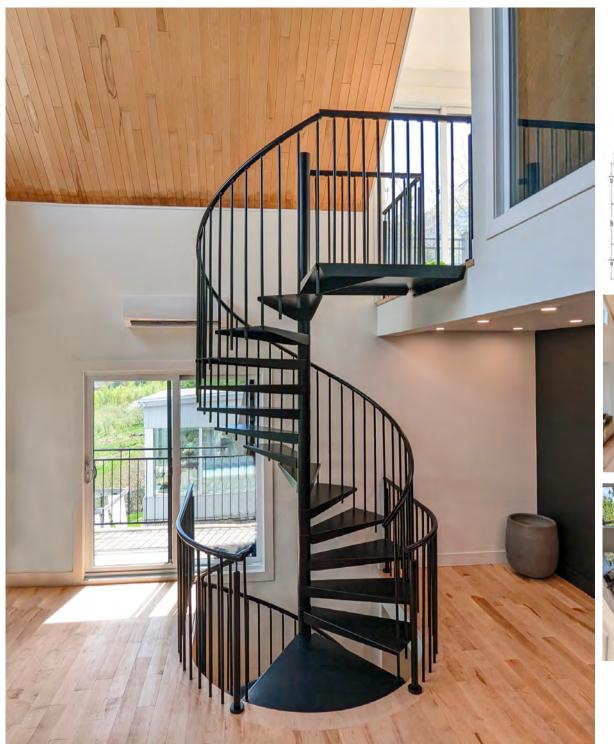
Steel stringer with steel steps. We have installed tree E 56 - E 67 models from Prestige Metal with balusters which finished under the step. Black color.

Spiral staircases are conform to the building code and have been approved by an engineer. It complies with the building regulations of the region where it's installed.

Each stringer is custom made thanks to a technical drawing. Spiral staircase is painted (powder paint) in our factory.

Installed a staircase in a limited space. This staircase is made up of 3 spiral staircases, one on top of the other with a square landing at the top.

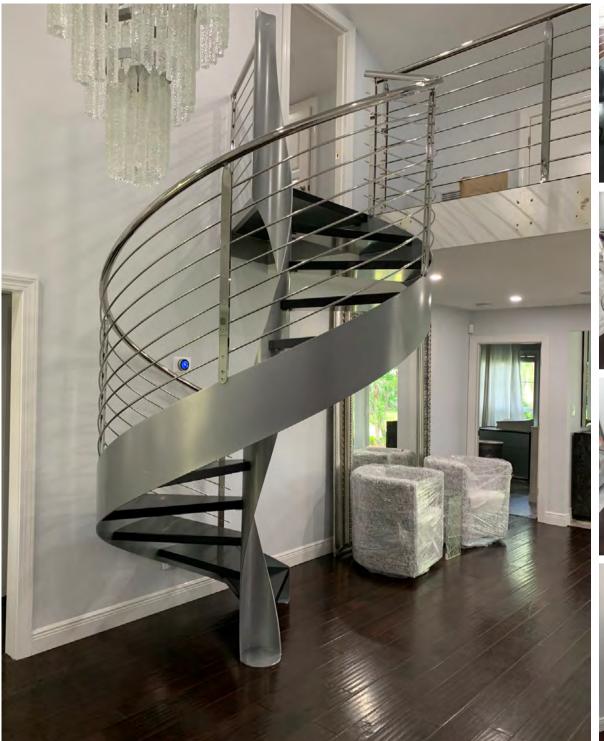
This spiral stair became a focal point of the home as it changed the entire design of the lower level. The central helical column and outside stringer enhanced the design of this modern masterpiece.

This stair has a 71" diameter making it much easier to walk than the original 36" diameter spiral that was in this home. Railing and spacing between horizontal rods comply with code.

The finish of the wood treads resembles the finish of a Steinway Piano. The metal stringer & center column have a custom powder coat finish as the client wanted it to resemble stainless steel.

The challenge was to fit a code compliant spiral in this villa to access a newly renovated 2nd floor livable area while still maintaining full use of the small lower level.

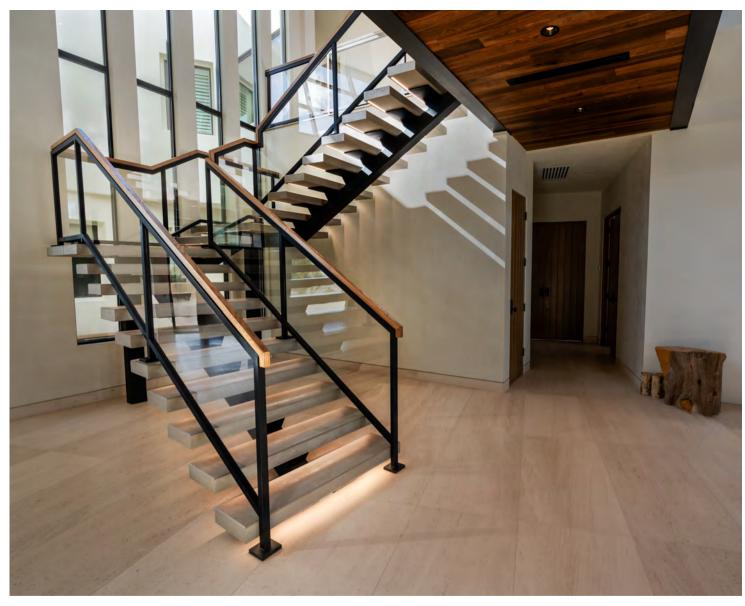
This mono stringer stairway has precast concrete treads. Resting on the concrete treads is an aluminum and glass railing system that is 100% custom. No visible fasteners, no visible glass hardware

The white oak handrail is fastened intricately around these difficult goose necks and corners you see in the images. It has a shadow line between it and the aluminum rail to give it a custom feel.

All the precast treads were poured with appropriate slots to receive LED lighting that runs through the stringer. This stair is now the showpiece of the home.

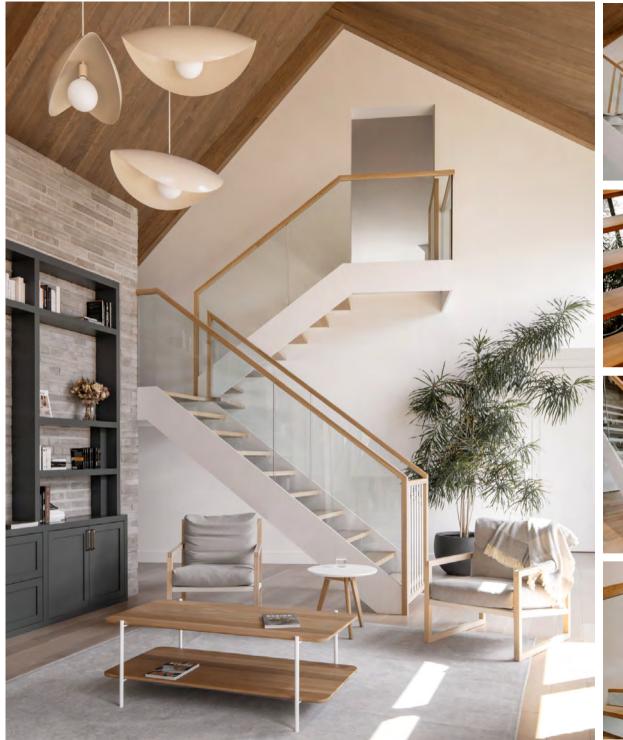
Double steel stringer to support its structure efficiently and uniformly. Subsequently, for a minimalist look, we recommended white stringer with glass railings and wooden steps.

Each stringer is custom made thanks to a technical drawing. Steel stringer is painted (powder paint) in our factory.

1 double steel stringer with a 180° landing

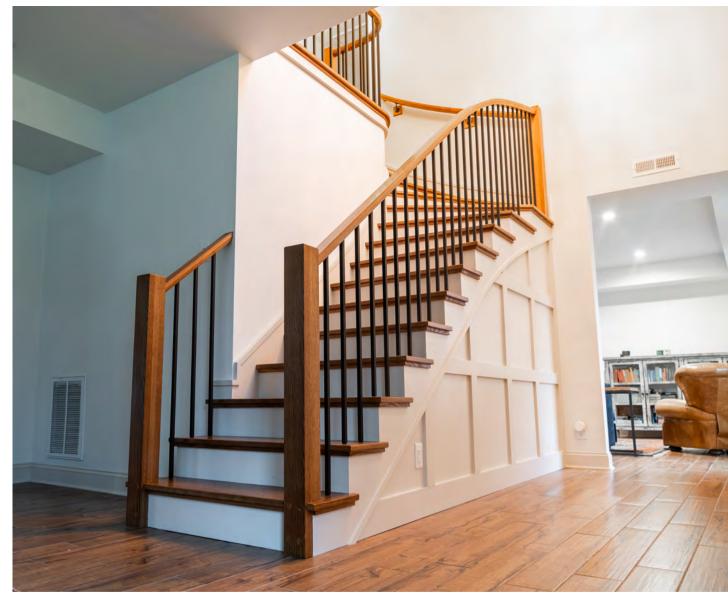
We incorporated three radius design aspects, making a contrast with all square parts. Because the handrail follows the sweep of the stringers we achieved a simple flowing appeal.

The original stair had 4" treads with carpet making it dangerous to ascend or descend. We now have a consistent Code-compliant walk line through the treads and winders.

This was CNC machined, shopbuilt utilizing mortise joinery techniques. The removal of intermittent newels gives it a consistent grasp of handrail, making it visually appealing.

Designing a safe, Code-compliant stair to fit into a small foyer where the original staircase was 40" from the front entryway. We now have 64 inches from the entryway to the stairs.

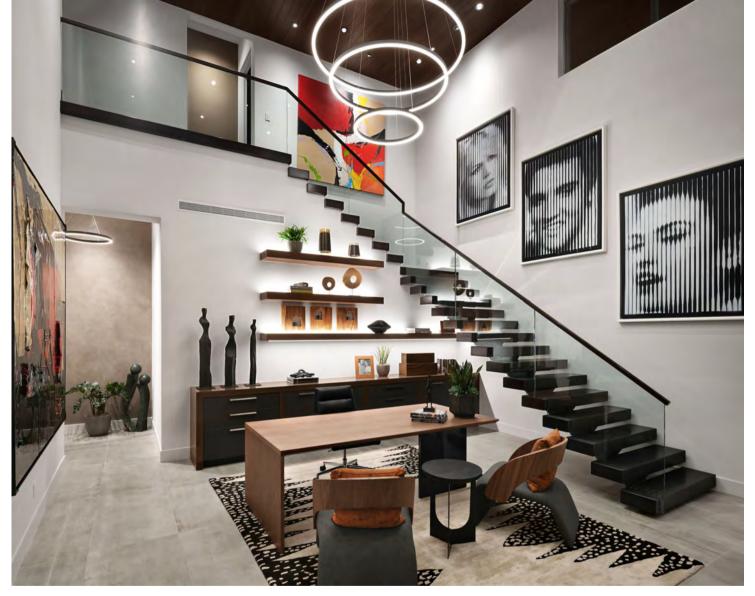
All the treads and rail are hard maple stained with a rich mocha stain. We match the framed in section to the floating section so all the treads have a uniform appeal to them.

The timeline for these stairs are extremely short. We have to be in and out so all the other trades can finish. Protecting the finished treads during the rest of construction has been a struggle.

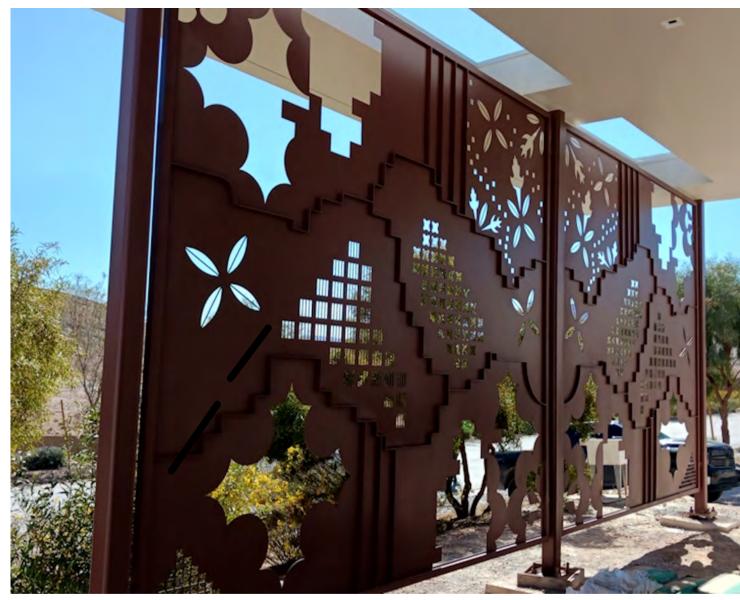
This project was a lot of fun. The client brought us a piece of tile that he would be using on the outside of the house. He taped off a small section of the tile and asked us to create him a beautiful screen on the front of his home that was inspired from the design found in the tile. It came out beautifully. We also created a dog run screen with an integrated gate on the back side of the house. These large featured were about 12' tall and 15' wide.
