Best Stairway Renovation

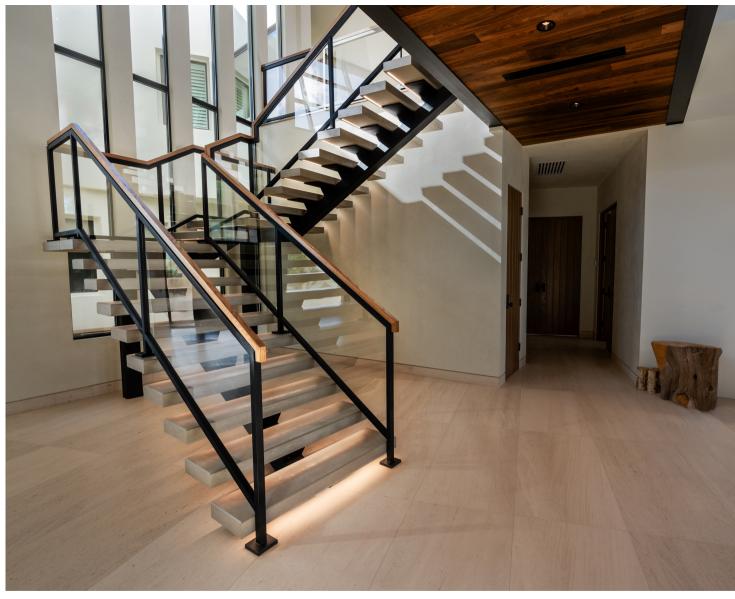
This mono stringer stairway has precast concrete treads. Resting on the concrete treads is an aluminum and glass railing system that is 100% custom. No visible fasteners, no visible glass hardware

The white oak handrail is fastened intricately around these difficult goose necks and corners you see in the images. It has a shadow line between it and the aluminum rail to give it a custom feel.

All the precast treads were poured with appropriate slots to receive LED lighting that runs through the stringer. This stair is now the showpiece of the home.

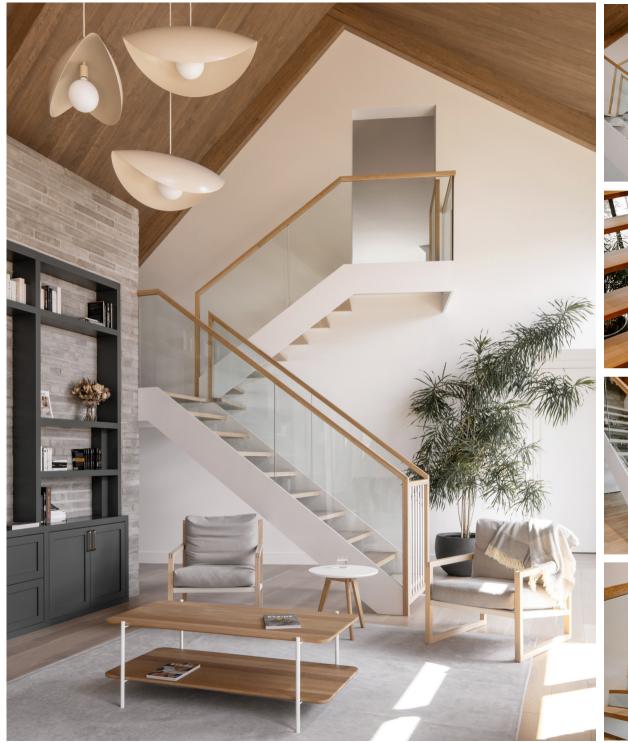
Double steel stringer to support its structure efficiently and uniformly. Subsequently, for a minimalist look, we recommended white stringer with glass railings and wooden steps.

Stringers conform to the building code and have been approved by an engineer. It complies with the building regulations of the region where it's installed.

Each stringer is custom made thanks to a technical drawing. Steel stringer is painted (powder paint) in our factory.

1 double steel stringer with a 180° landing

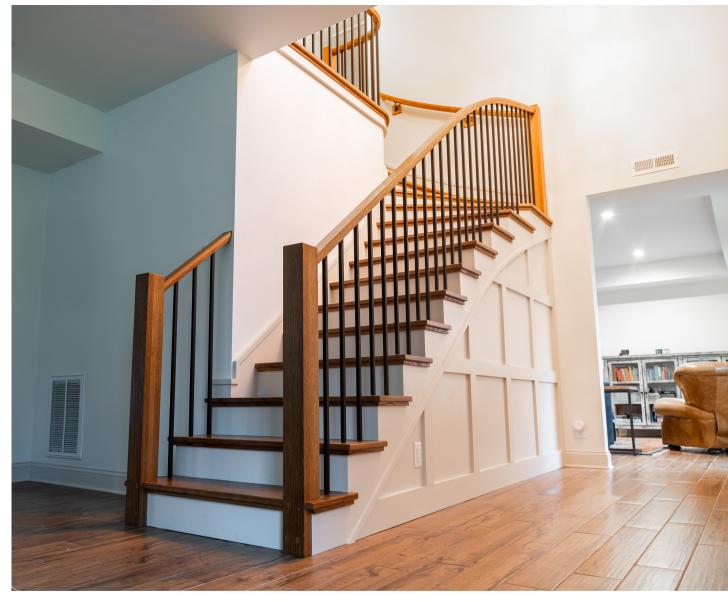
We incorporated three radius design aspects, making a contrast with all square parts. Because the handrail follows the sweep of the stringers we achieved a simple flowing appeal.

The original stair had 4" treads with carpet making it dangerous to ascend or descend. We now have a consistent Code-compliant walk line through the treads and winders.

This was CNC machined, shopbuilt utilizing mortise joinery techniques. The removal of intermittent newels gives it a consistent grasp of handrail, making it visually appealing.

Designing a safe, Code-compliant stair to fit into a small foyer where the original staircase was 40" from the front entryway. We now have 64 inches from the entryway to the stairs.

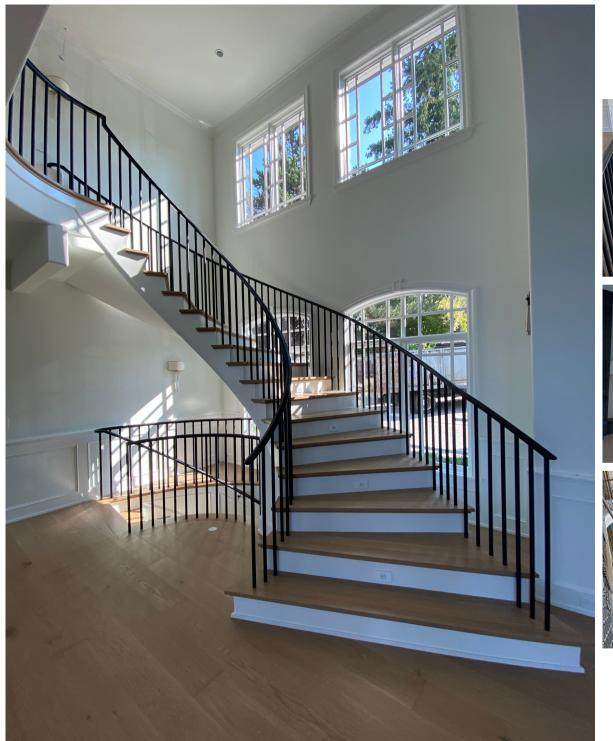
Clean Modern Design without a Newel Post

Quality of Workmanship: Highest Quality fully Fabricated Steel Design

Fully Fabricated Curved Steel Stair System without Newel Posts
